# DENSO Lambda Sensors

Discovering superior DENSO technology

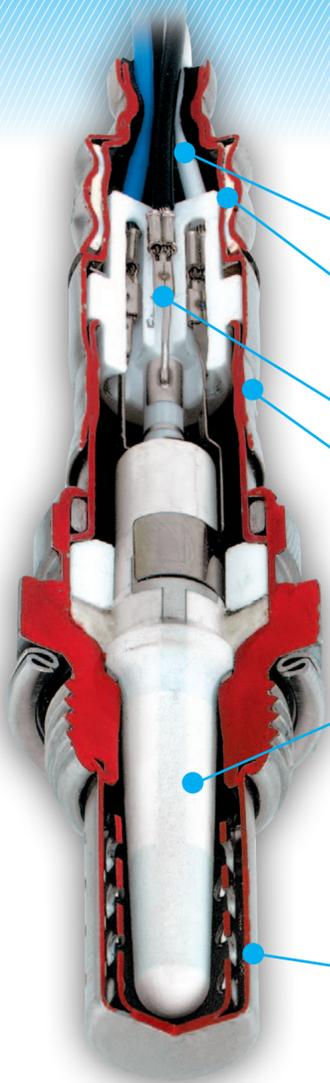
## Characteristics

**Steel core in wires:** The Teflon isolated wires have a core of stainless steel strands for extra strength, surrounded by nickel coated copper wires for good conductivity and low resistance.

**Porous PTFE filter:** Allows atmospheric oxygen to enter the Sensor without permitting water or engine contaminants to seep into the casing.

**Robotic laser welded connection:** Ensures long and reliable operation.

**Stainless steel housing:** Resists corrosion and contamination with a rugged, watertight body.

**Aluminium-oxide double trap layer:** DENSO Lambda Sensors feature a unique protective coating of aluminium oxide on the ceramic element to help ensure the Sensor takes accurate measurements and ensure a long lifetime. The coating helps to:

**Double protection cover:** Maintains proper unit temperature for quicker response times and protects the ceramic element against silicone and lead poisoning.
